Exterior Architectural Finishes in Puerto Rico: The Painting Traditions of Guayama's Vernacular Architecture

Betty L. Prime
University of Pennsylvania

Prime, Betty L., "Exterior Architectural Finishes in Puerto Rico: The Painting Traditions of Guayama's Vernacular Architecture" (2011). *Theses (Historic Preservation)*. 164.
http://repository.upenn.edu/hp_theses/164

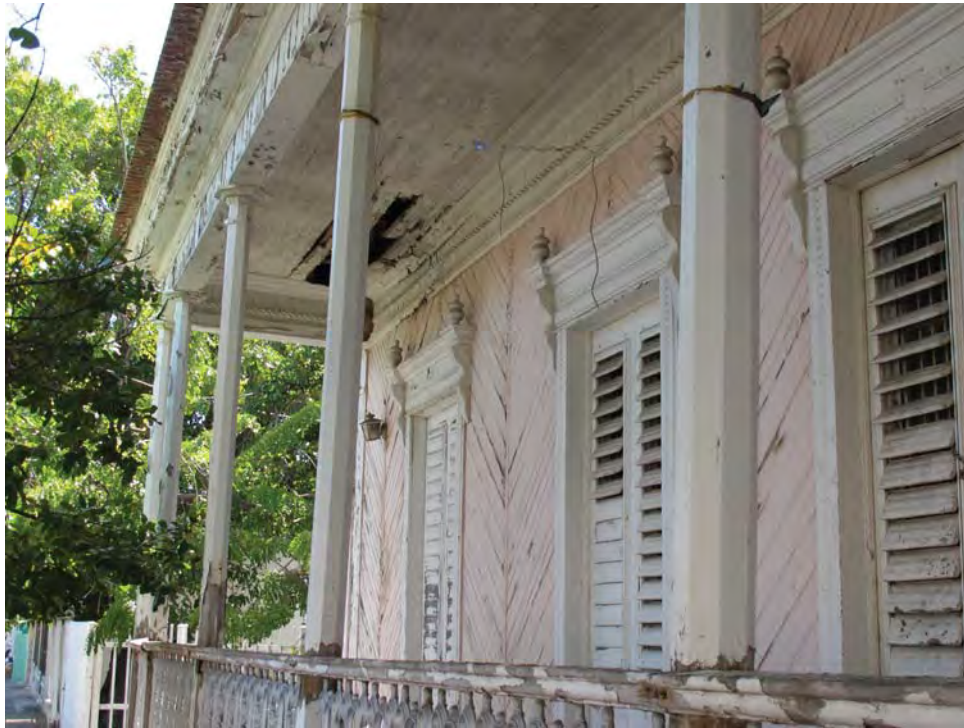
Figure 3.1: Photograph of Vernacular Creole house. Note diagonal herringbone siding. (author)

The siding of the facades is variable across each building typology. Types of siding include plain and beaded clapboard, herringbone, cove, ship-lapped, and flush (figures 3.1 and 3.5).

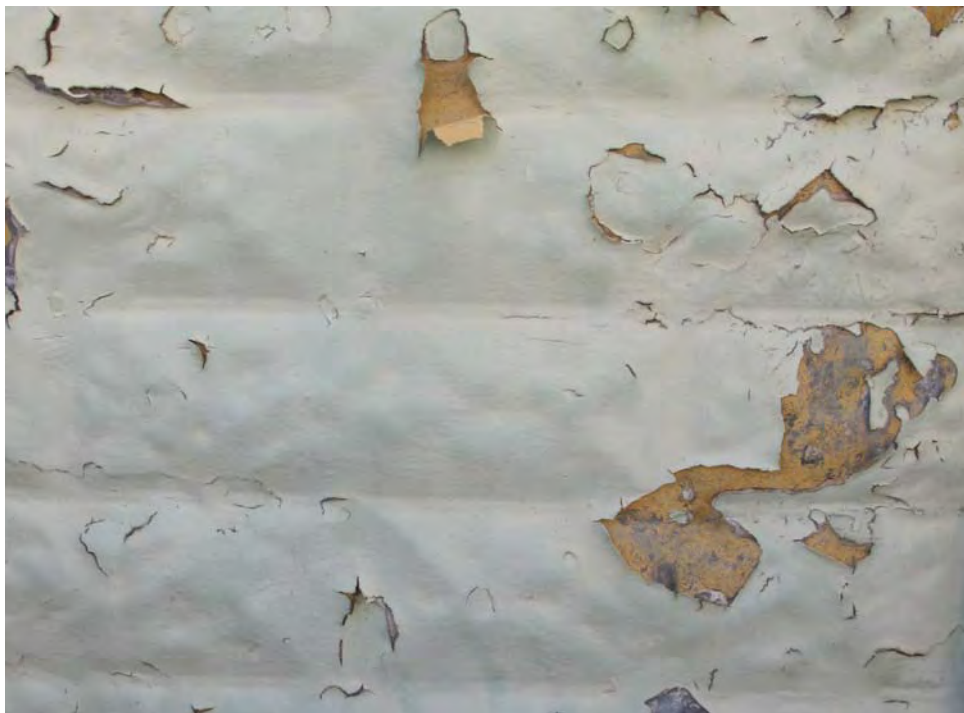
Figure 3.2: Photograph of zinc siding panels commonly used on the side elevations of Vernacular Creole houses. The stamped pattern seen here is unique. Most panels used in Guayama are flat. (author)

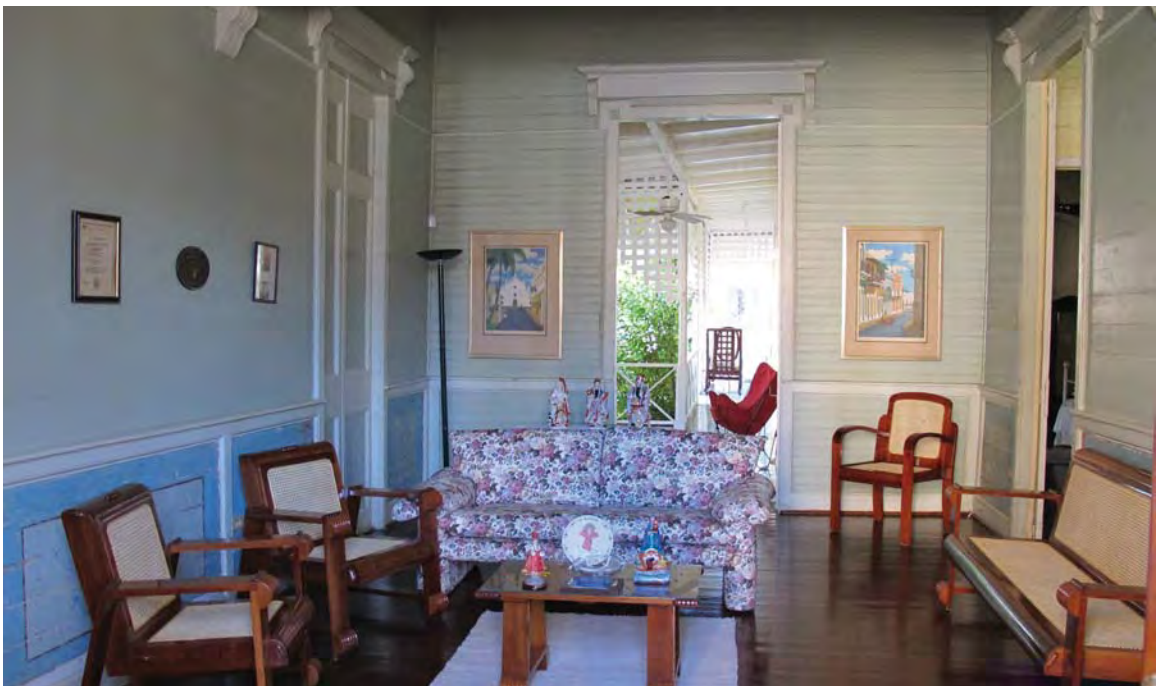
Figure 3.4: Photograph of the interior of typical 3-bay Vernacular Creole house. This house is located at 6 E. Cecelio Dominguez Street. Note original decorative painting on the lower panels of the wall. (author)

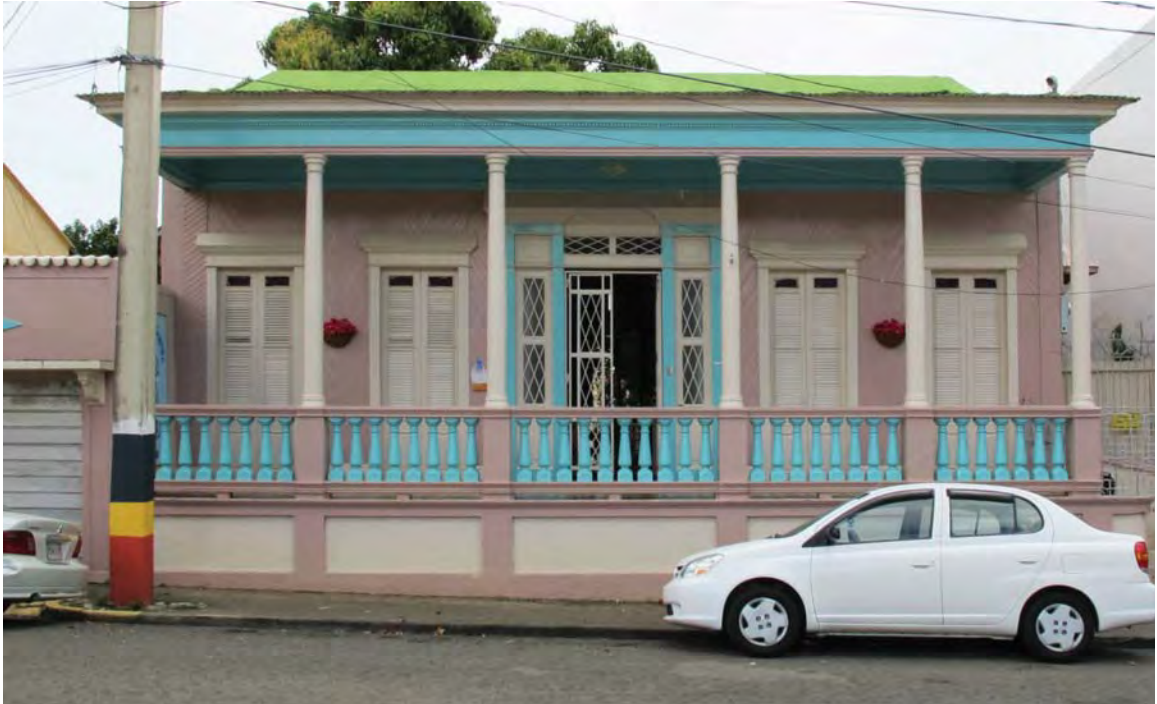
Figure 3.5: Photograph of the exterior of Vernacular Creole house. This house is located at 4 E. Cecelio Dominguez Street. (author)

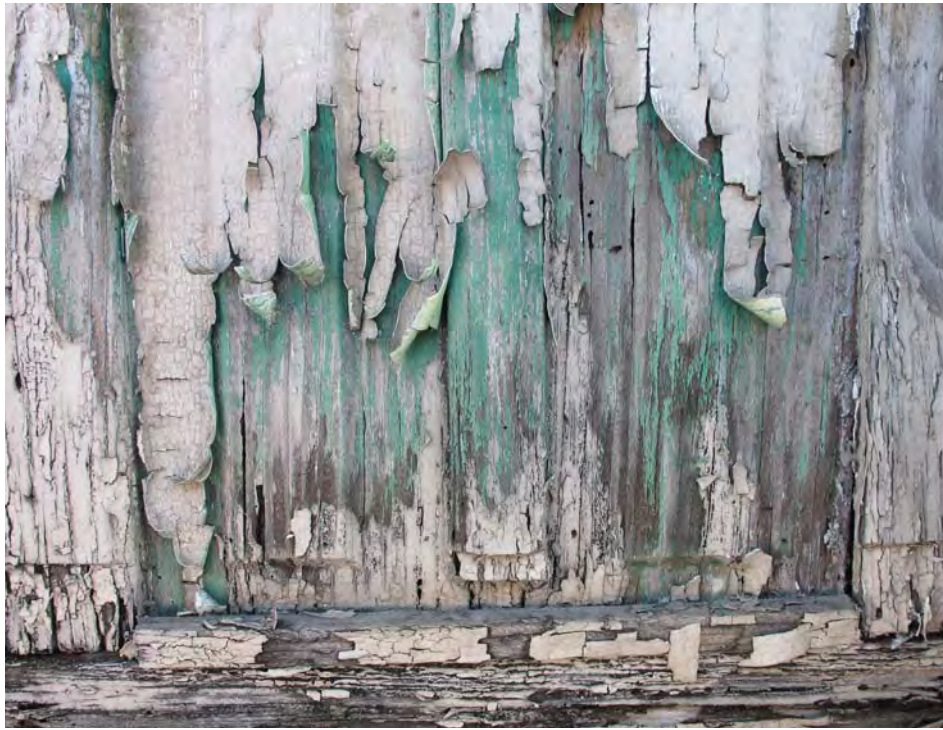
Figure 3.8: Photograph of paint detaching from wood paneling at 88 N. Santiago Palmer Street. (author)

Wooden houses constructed in Puerto Rico prior to 1898 used native hardwood trees for all decorative and structural elements.³² Common species employed by builders included ironwood (ausubo), red-cotton silk, rainwood (carreto), lignumvitae (guayacan), yellow poui, Spanish elm, almond, and mahogany.³³ Ausubo was frequently used for structural members because of its resistance to rot and termites. The hardwood materials used in the construction of historic structures came from mature trees and were cut according to the lunar cycles; which contribute to their resilience.³⁴ In the late nineteenth century Puerto Rico began importing pine from the United States. The imported pine was susceptible to carpenter ants and termite infestation; making the structures constructed from these materials less durable than those built using native hardwood trees (figure 3.9). Correlations can be made between the condition of Guayama's wooden building stock and the materials source. Houses constructed prior to the importation of foreign wood are in better condition than those built with pine. It is not uncommon for houses built in the 1940s to have completely replaced much of their wooden siding and trim where as older more well maintained structures built as early as 1870 still retain their original material (figure 3.8).

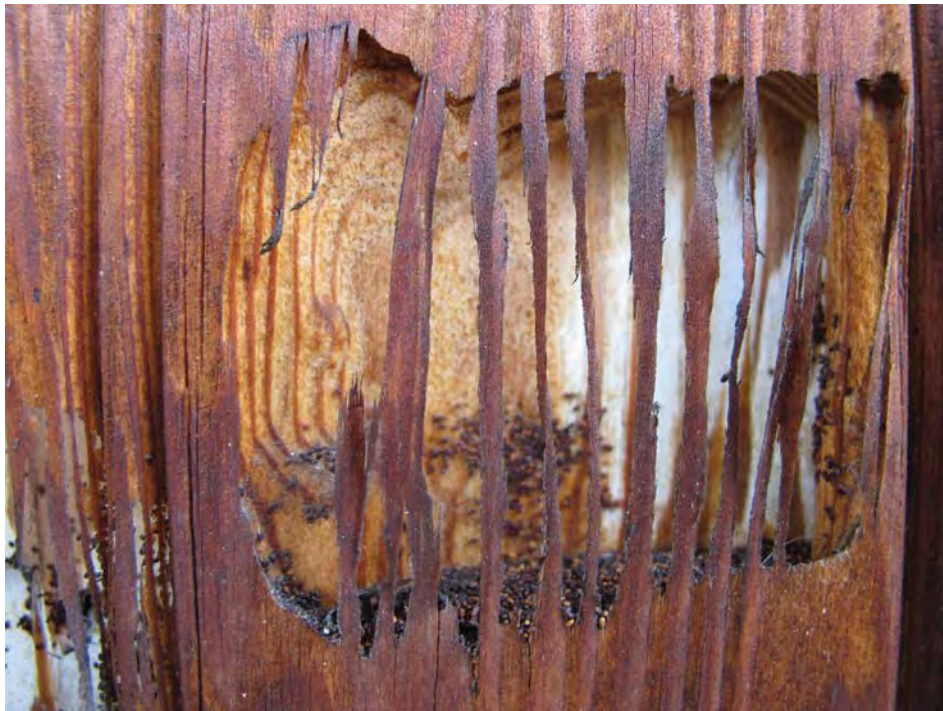
Figure 3.9: Photograph of insect damage on a wood structural member; visible at far southern bay at the front elevation at 3 N. Ashford Street. (author)

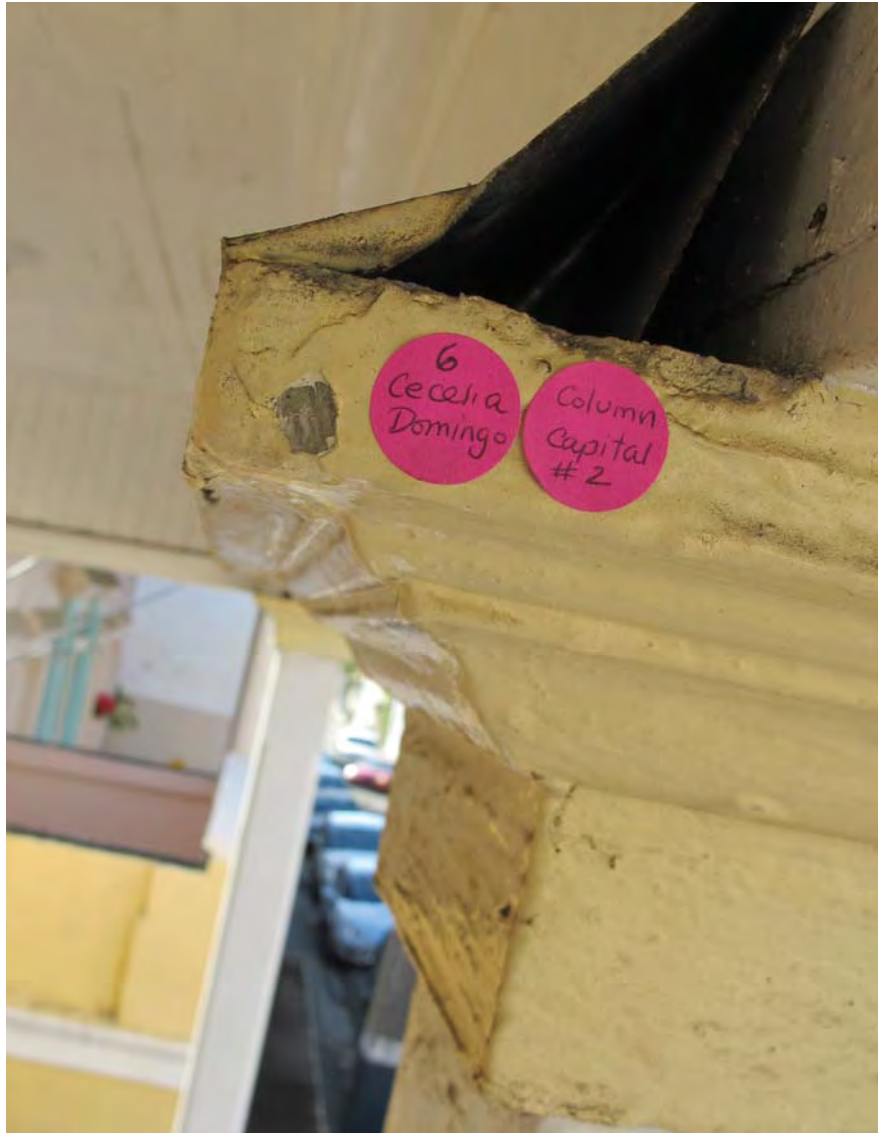
Figure 5.1: Photograph of sample extraction from a column capital at 6 E. Cecelio Dominguez Street. (author)

Prior to sample removal, extraction sites were labeled with colored 3m dots indicating the house address (figure 5.1). Focusing on the porches (balconies) of each house, samples were extracted from wooden architectural elements (i.e. walls, bases, railings, columns, doors, windows, trim, and ceilings) (figures 5.2 and 5.3). When possible, samples were taken in areas protected from weather and human contact. Most of the houses examined for this study were privately owned; efforts were made to sample in a manner that did not affect the aesthetics of the wall. In some cases, however, it was necessary to take samples from highly visible locations.

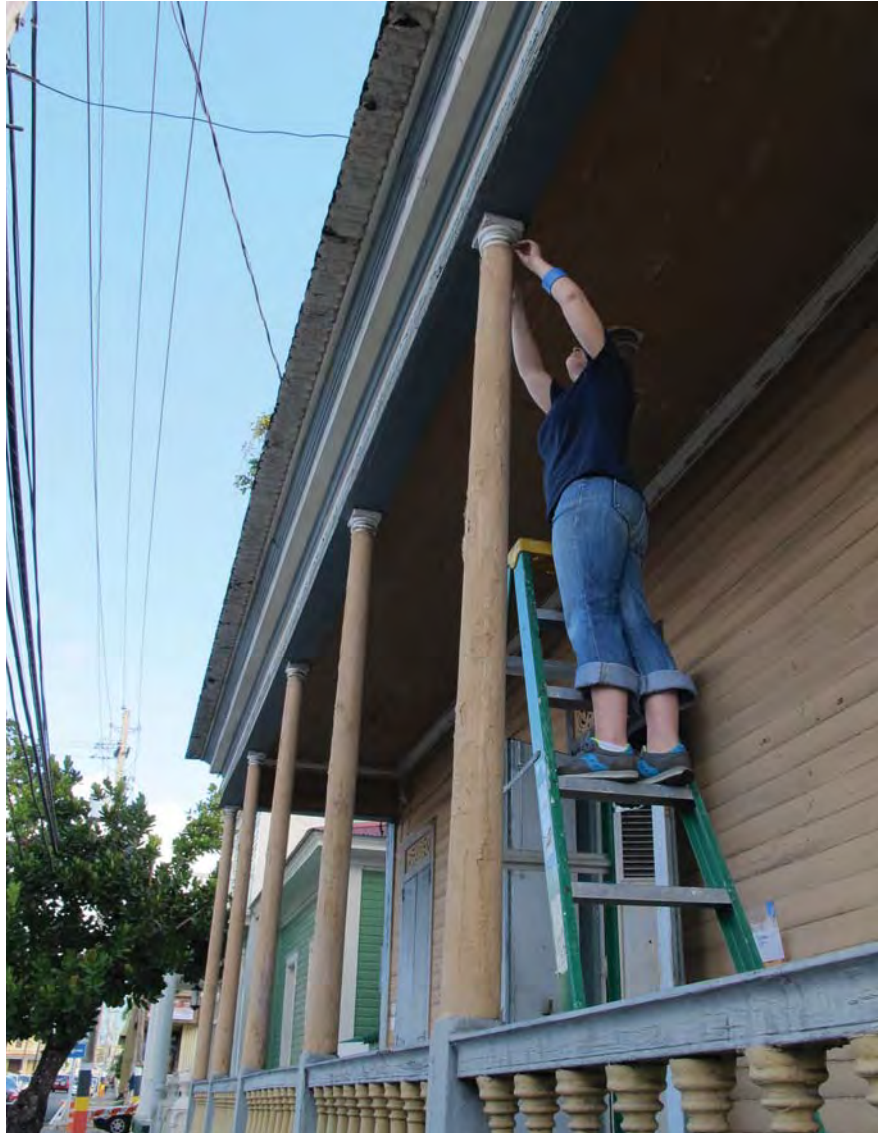
Figure 5.2: Photograph of sample extraction from a column capital at 43 S. Ashford Street. Ladders were used to access architectural features not accessible from the ground. (author)

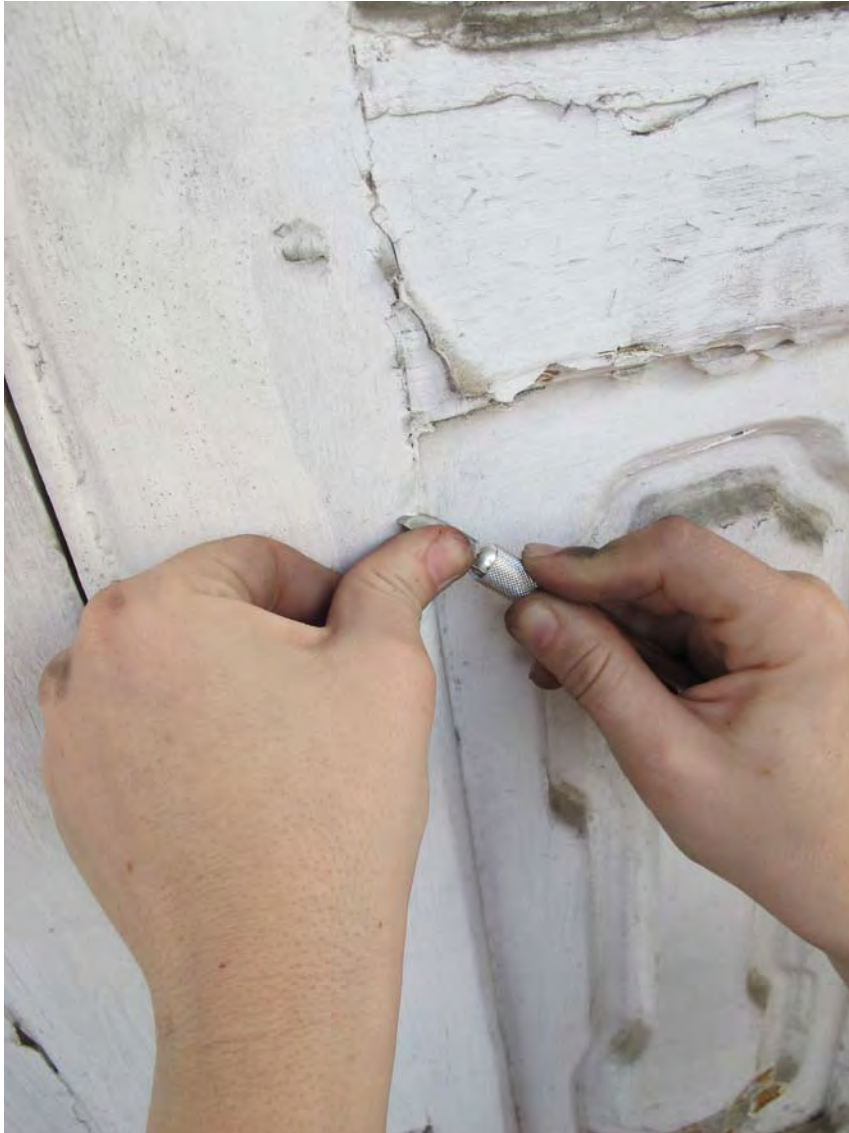
Figure 5.3: Photograph of sample extraction from a door using a curved exacto blade at 3 S. Ashfrod Street.
(author)

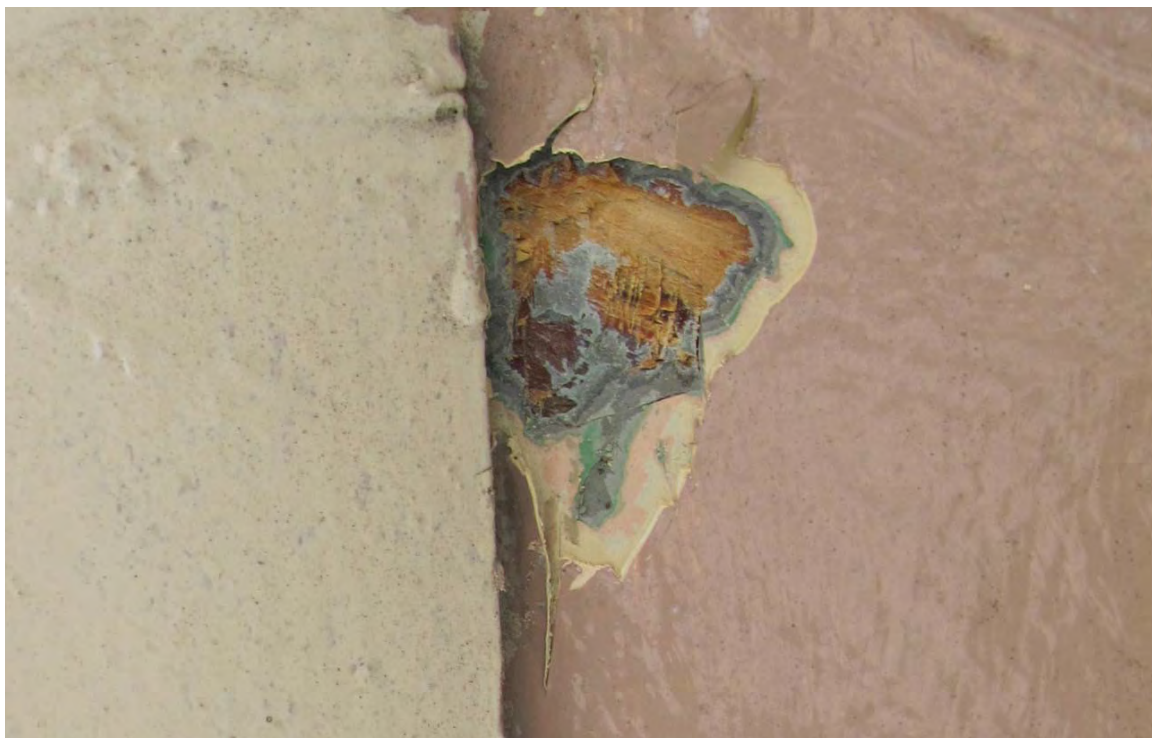
Figure 5.4: Photograph of sample exposure adjacent to a door at 4 E. Cecelio Dominguez Street. Some early layers of paint were brittle, small exposures were made to ensure that all layers were included in the extracted sample. (author)

Additional exposures were made in instances of brittle paint, to ensure that samples with broken paint-to-substrate bonds contained all extant paint layers (figure 5.4). This method also proved helpful in understanding variation in samples. Several instances of scraped paint were found; where only residual paint layers remained. Crevices of door panels and concrete bases were common locations for inconsistent paint stratigraphy. These elements had variable surface topography, making complete paint removal difficult.

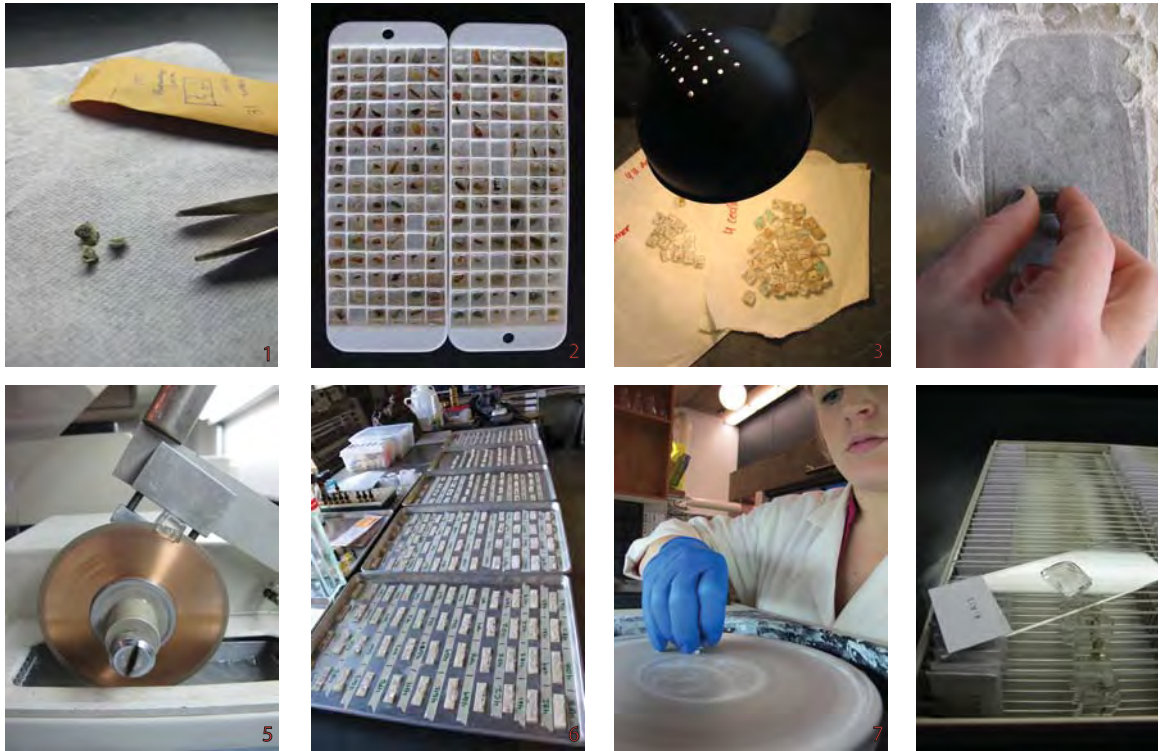
Figure 5.5: Photographs of cross-section paint sample preparation. The steps include: 1) selection of sample from multiple samples extracted from a single architectural feature 2) sample casting in small ice cubes using Bioplast resin 3) drying samples using 60w bulb 4) sanding meniscus off of dried sample 5) dividing cubes to reveal cross-section of paint sample using an Isomet slow saw 6) all cut samples organized by house for polishing 7) polishing samples on Ikomet using .005 8) paint cross sections mounted onto glass slides with Cargille meltmount. (author)

All samples extracted from the field were transported to the Architectural Conservation Laboratory at the University of Pennsylvania and prepared for microscopic analysis. Samples were preliminarily examined using a stereo-binocular microscope to select best candidates for cross-section analysis. Multiple samples were taken from representative architectural elements on the elevations during field sampling. Casting priority was given to intact samples with attached substrate. Of the 500 samples extracted in the field, 200 were processed into thick sections and analyzed (figure 5.5).

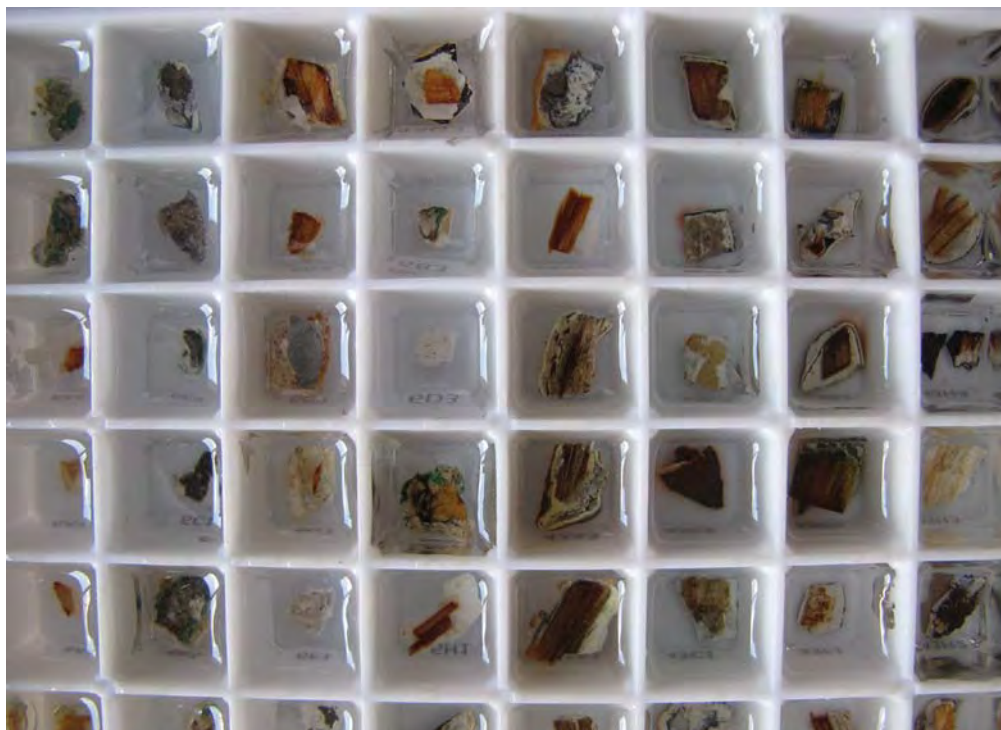
Figure 5.6: Close up photograph of paint samples cast in Biolplast resin. (author)

Selected paint samples were cast into small mini-ice cube trays using Bioplast® polyester monomer resin and methylethylketone (MEK) peroxide catalyst (figure 5.6). Bioplast® was the preferred mounding medium due to its transparency and stability. In addition the resin was relatively soft, making it compatible with the variable hardness of the paint samples. Prior to casting, tray cells were coated with Bueler mold release agent and allowed to dry for one hour under a 60 watt incandescent light. Coating cells before use reduces the probability of sample adhesion to the sample mold.

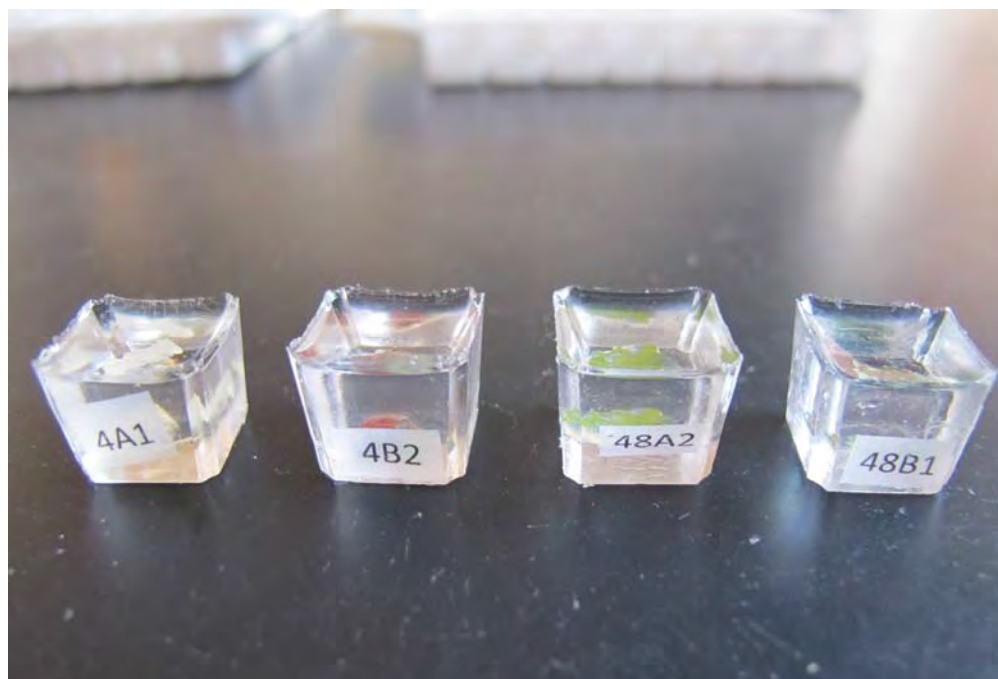
Figure 5.7: Photograph of paint sample cubes following removal from the mini ice cube trays. Note sample labeling is embedded into the sample. (author)

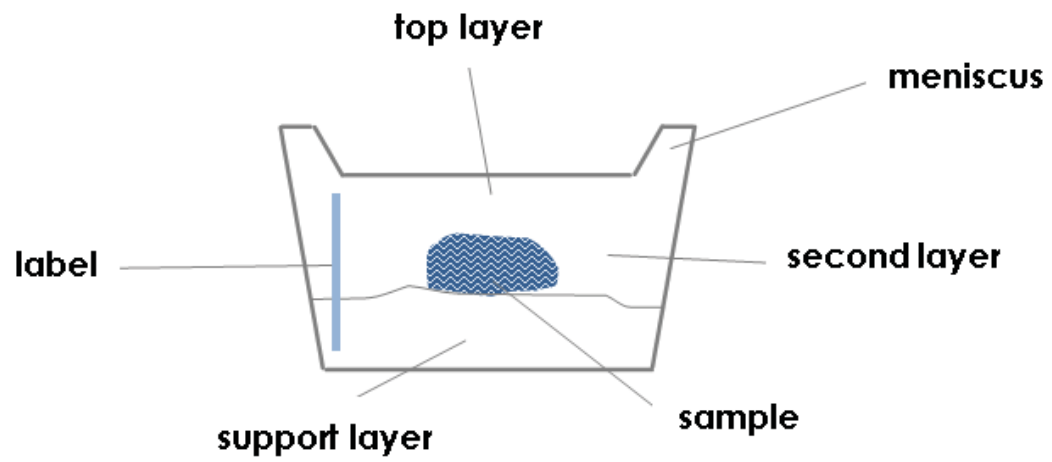
Figure 5.8: Diagram of casted paint sample denoting pour layers and embedded label. (diagram courtesy of Vicky Pingarron Alvarez)

Samples were cast in two pours to prevent buoyant materials, such as the wood substrate, from floating to the surface. The first pour acts as a support layer for the sample. Once placed into the cells, the mounting medium was allowed to cure for 12-18 hours. Paint sections were then centered in each cell cube and covered with resin (figure 5.7). Small labels were cast in each sample. All sample labels were printed using toner based printers to prevent labels from bleeding into the casting medium (figure 5.8). Samples were allowed to cure for 7

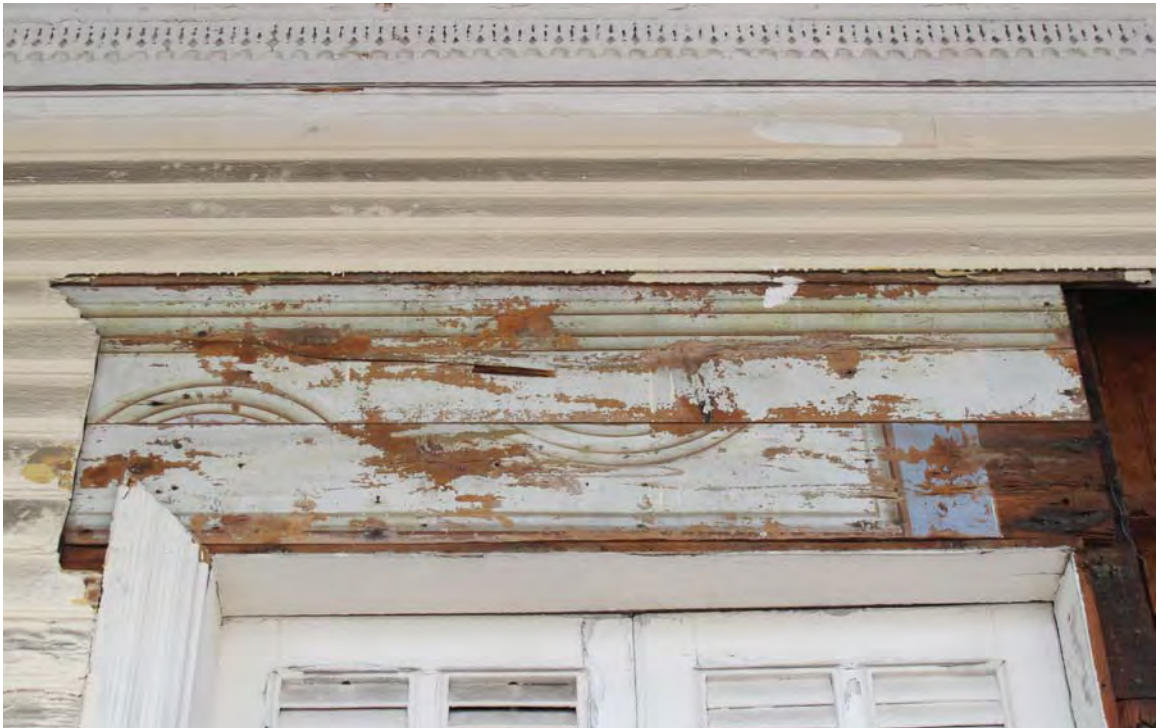
Figure 6.1: Reclaimed tromp l'oeil panels were discovered above the door at the far bay on the south side of the façade at 3 S. Ashford Street. (author)

Note: Evidence of reused material was found behind the siding boards. Reclaimed trompe l'oeil panels were discovered above the door at the far bay on the south side of the façade (figure 6.1)

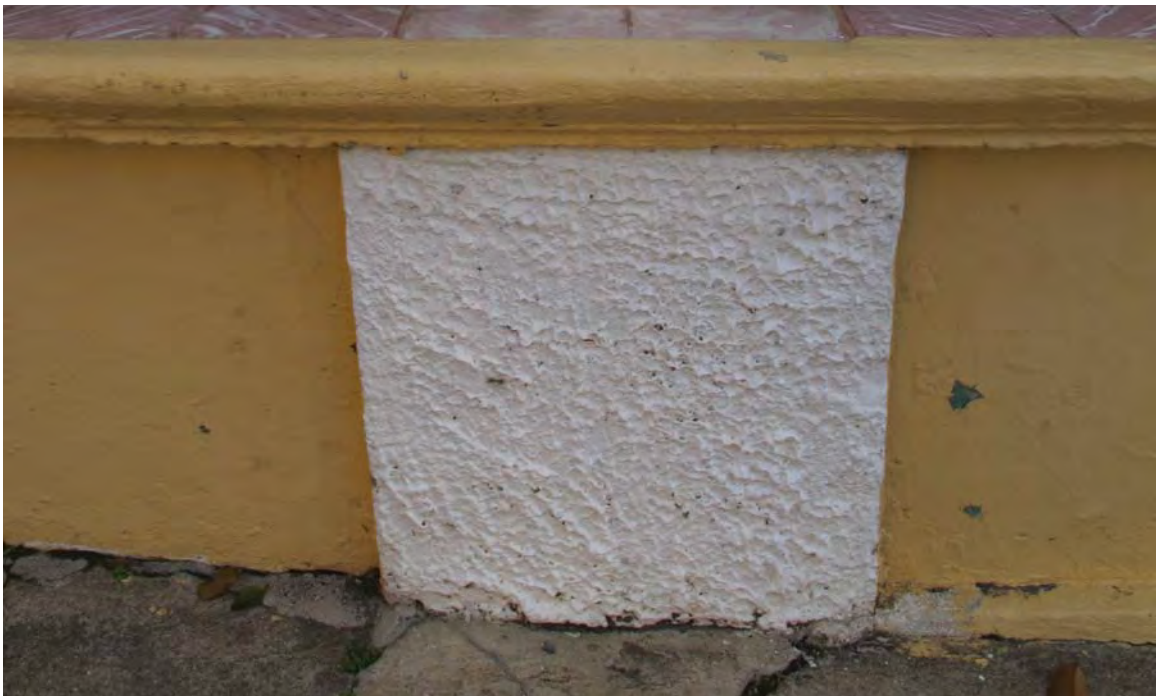
Figure 6.2: Photograph of altered building base at 6 E. Cecelio Dominguez Street. (author)

The columns, railings, and balusters are not original to the structure. Paint stratigraphies found on these elements are similar to those found on the textured segments of the base below each column (figure 6.2). This may indicate that the alterations were made at the same time. The cornice of this house has been completely replaced. No decorative history is available for this element.

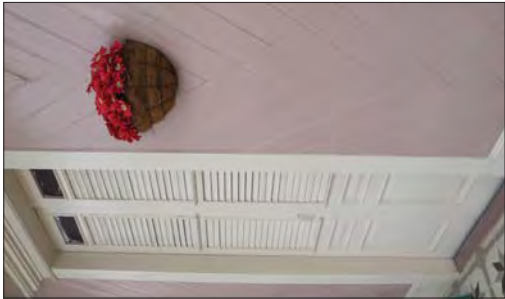
Architectural Details:

Material Description:

Architectural Element	Material
Body/Walls	wood, beaded diagonal siding
Building Base	concrete
Columns	concrete
Porch Railing	concrete
Porch Handrail	concrete
Door	wood
Door Enframement	wood
Cornice	wood
Window Frame	-
Window Sills	-
Window Louvers/Shutters	-
Ceiling	wood
Pavement	tile on concrete

glass replaced in central and side doors, original railing and balusters replaced with concrete, original columns replaced with concrete, possible alterations to central door and sidelights, replacement siding at west side of building

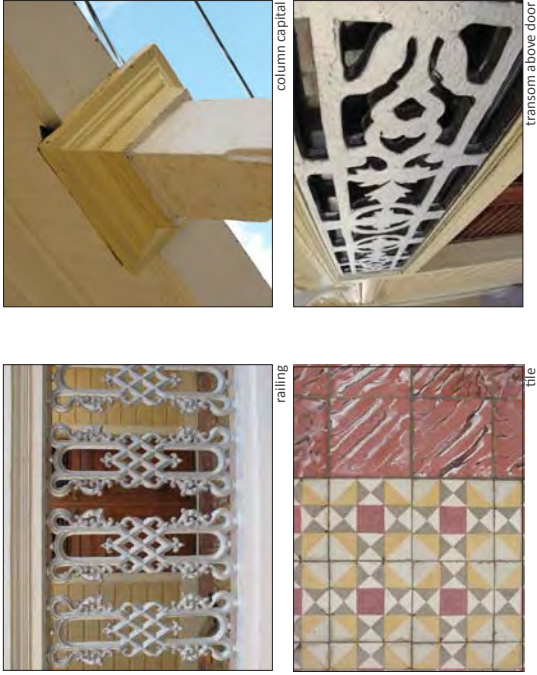
Architectural Details:

Material Description:

Architectural Element	Material
Body/Walls	wood, original cove siding
Building Base	concrete
Columns	concrete
Porch Railing	iron
Porch Handrail	concrete
Door	wood
Door Enframement	wood
Cornice	wood
Window Frame	-
Window Sills	-
Window Louvers/Shutters	-
Ceiling	wood
Pavement	tile on concrete

original doors replaced, baseboard new except for far west corner, siding partially replaced, elements of ceiling board replaced, exterior cornice and fascia boards new, cornerboards new, original columns replaced with concrete, bottom rail of railing and handrail replaced, original balusters replaced with cast iron decorative panels

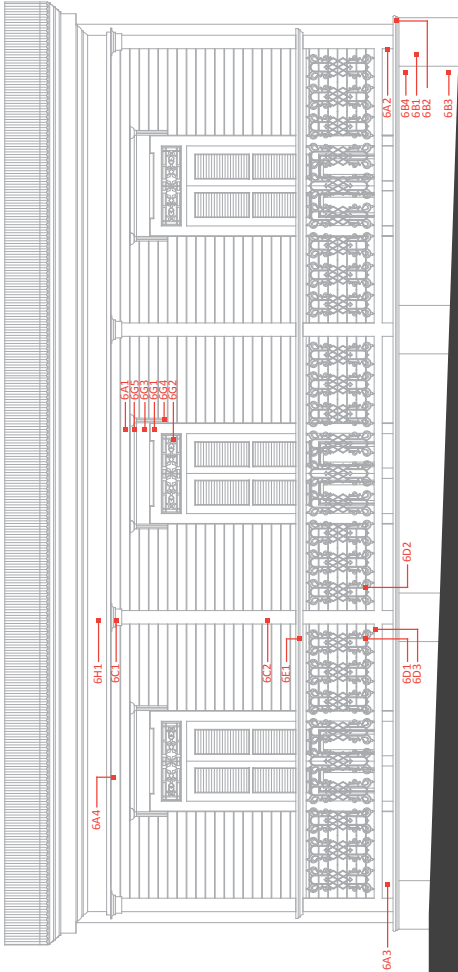
[Sample Key]

<u>Sample #</u>	<u>Sample Location</u>	<u>Sample #</u>	<u>Sample Location</u>
6 : A : 1	Wall (siding, west side of main door)	6 : D : 1	Porch Railing (middle)
6 : A : 2	Wall (trim board at wall, original)	6 : D : 2	Porch Railing (middle #2)
6 : A : 3	Wall (baseboard)	6 : D : 3	Porch Railing (base)
6 : A : 4	Wall (trim directly above siding)	6 : E : 1	Porch Handrail
6 : B : 1	Base (frosting under columns)	6 : G : 1	Door Frame (top detailing)
6 : B : 2	Base (right hand corner of frosting)	6 : G : 2	Door Frame (middle door, transom)
6 : B : 3	Base (middle panel, bottom)	6 : G : 3	Door Frame (pediment, flat detail)
6 : B : 4	Base (middle panel)	6 : G : 4	Door Frame (pediment, west detail)
6 : C : 1	Column (capital)	6 : G : 5	Door Frame (top of pediment main door)
6 : C : 2	Column (middle)	6 : H : 1	Cornice/Soffit (fascia board west)

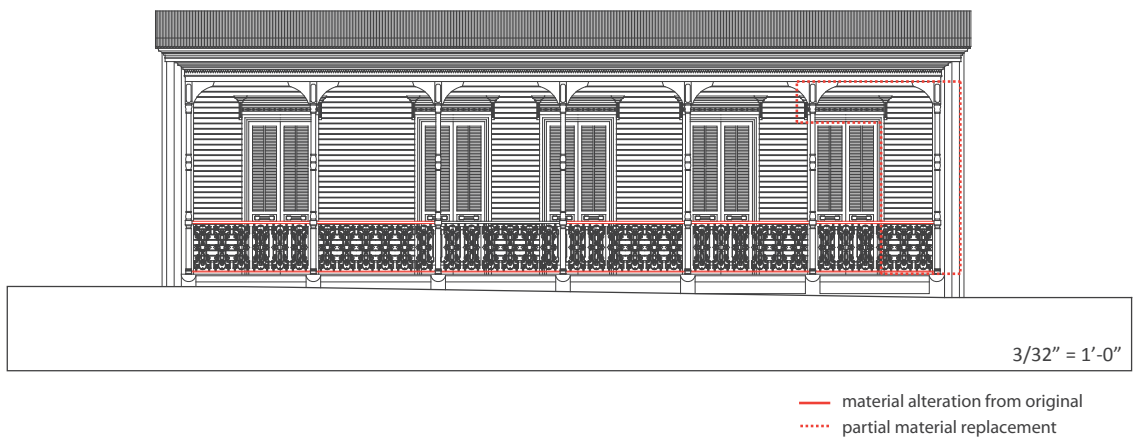
[Map of Material Alterations]

far north bay of house is missing siding and pediment above door; all but one bay of railing handrail has been replaced with iron, south side of cornice has been replaced, cornerboard missing on north side, probable repair on south side

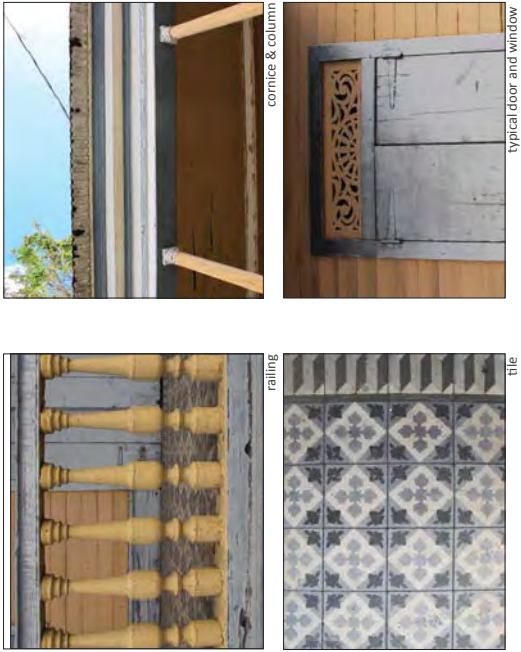
Architectural Details:

Material Description:

Architectural Element	Material
Body/Walls	wood, flush mounted siding
Building Base	concrete
Columns	wood
Porch Railing	wood
Porch Handrail	wood
Door	wood
Door Enframement	wood
Cornice	wood
Window Frame	wood
Window Sills	wood
Window Louvers/Shutters	wood
Ceiling	wood
Pavement	tile on concrete

Alterations to Structure:
 new iron railing at south porch entrance, parital repair of cornerboards

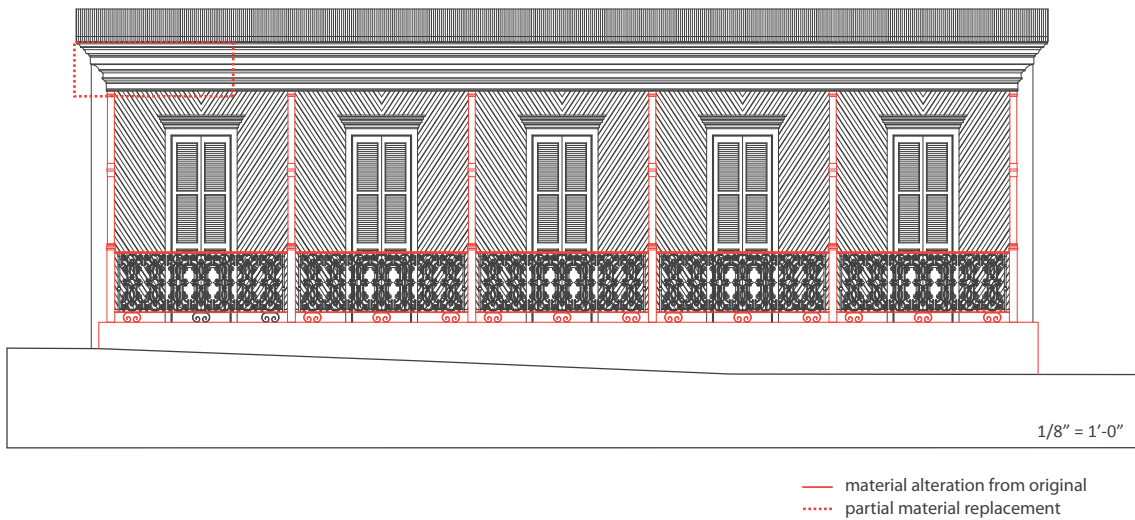
[Map of Material Alterations]

original handrail replaced with aluminum, bottom rail of railing replaced with iron, south end of cornice has been partially replaced, door hardware has been changed, original wooden columns replaced with galvanized pipe

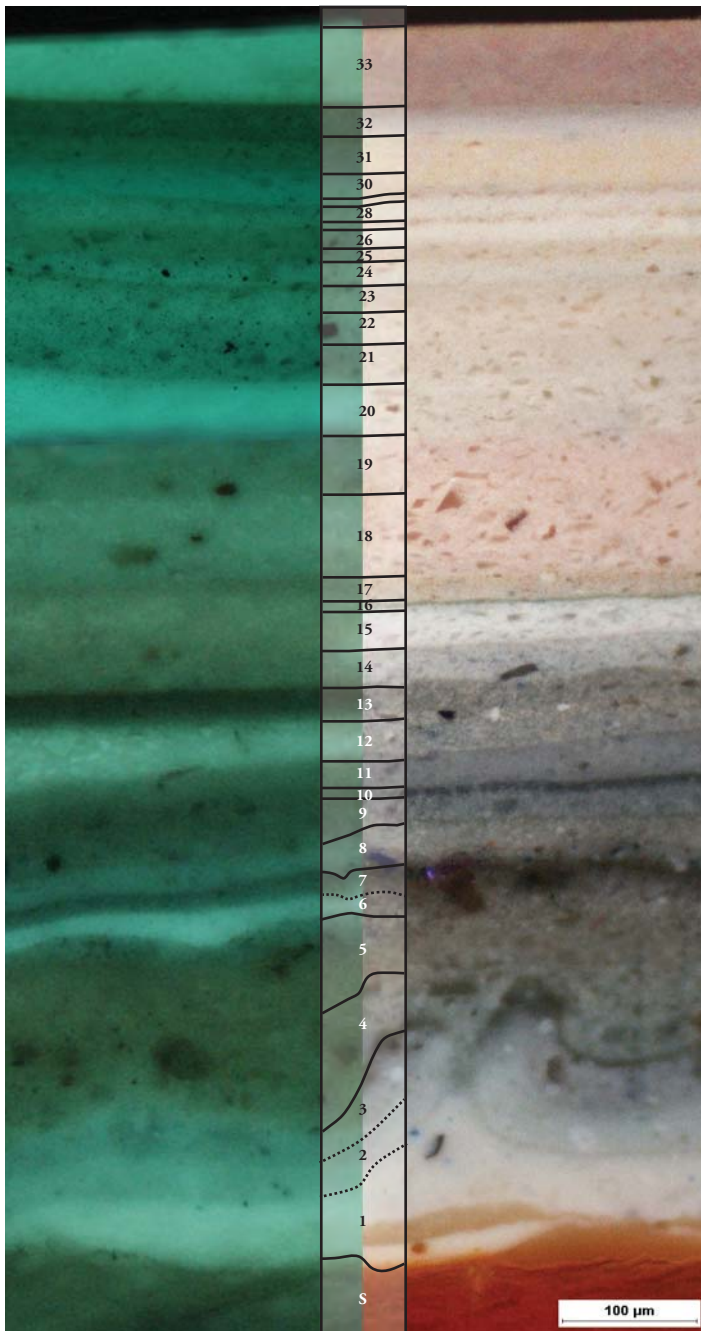
Sample Number: 4 :A: 1	Element: wall	Date Sampled: 02/13/11
Sample Location: siding		Date Analyzed: 03/25/11
Substrate: wood	Illumination: Fluorescence BV 1A, Reflected/Quartz Halogen	
Microscope: Nikon ALPHAPHOT2-YS2		Objective: 10x
Analysis Performed by: Betty Prime		Camera: Nikon DS-Fi1

Stratigraphy

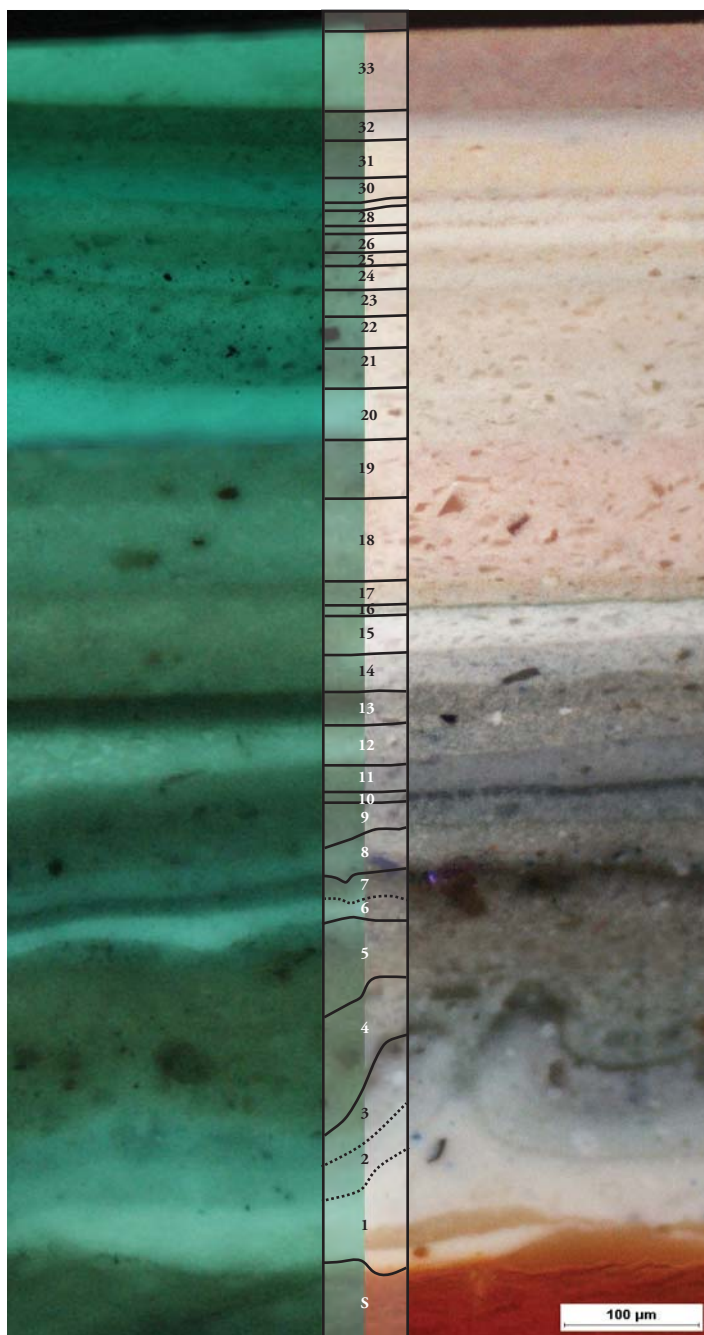
Sample Number: 4 :A: 1	Element: wall	Date Sampled: 02/13/11
Sample Location: siding		Date Analyzed: 03/25/11
Substrate: wood	Illumination: Fluorescence BV 1A, Reflected/Quartz Halogen	
Microscope: Nikon ALPHAPHOT2-YS2		Objective: 10x
Analysis Performed by: Betty Prime		Camera: Nikon DS-Fi1

Stratigraphy

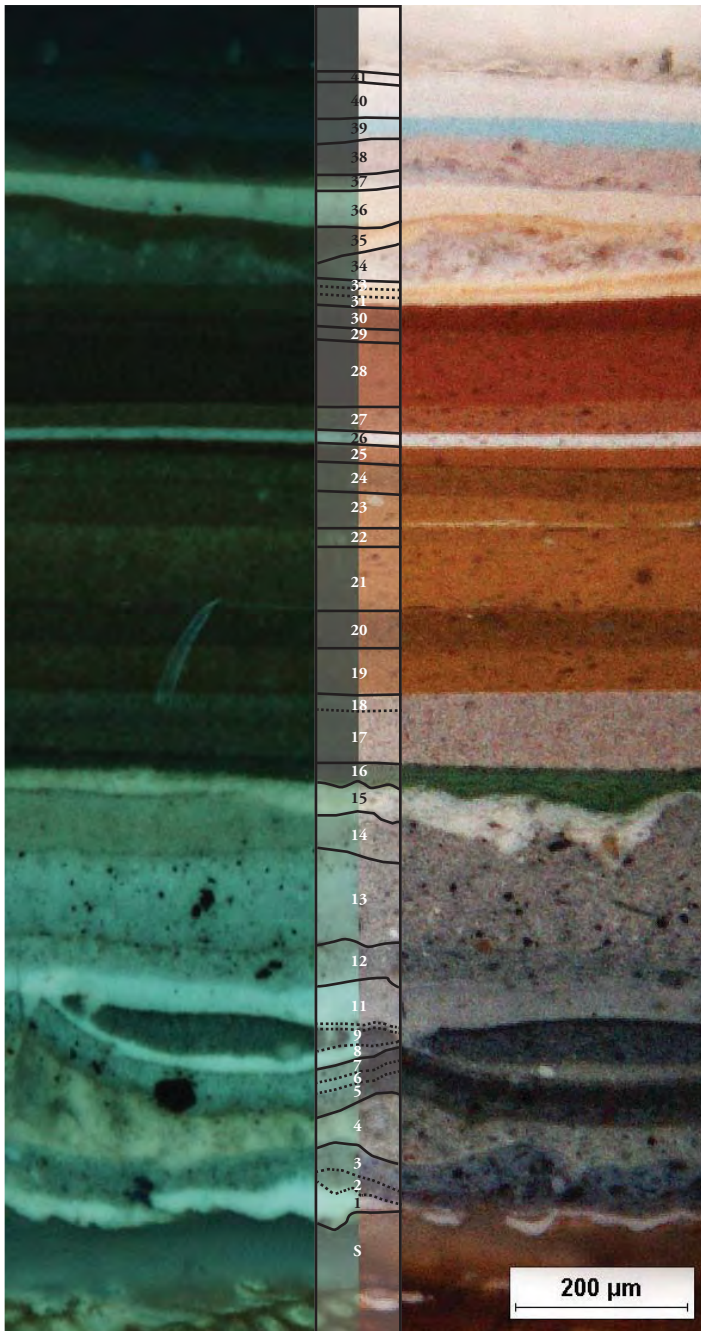
Sample Number: 4 :A: 4	Element: wall	Date Sampled: 02/13/11
Sample Location: baseboard		Date Analyzed: 03/25/11
Substrate: wood	Illumination: Fluorescence BV 1A, Reflected/Quartz Halogen	
Microscope: Nikon ALPHAPHOT2-YS2		Objective: 4x
Analysis Performed by: Betty Prime		Camera: Nikon DS-Fi1

Stratigraphy

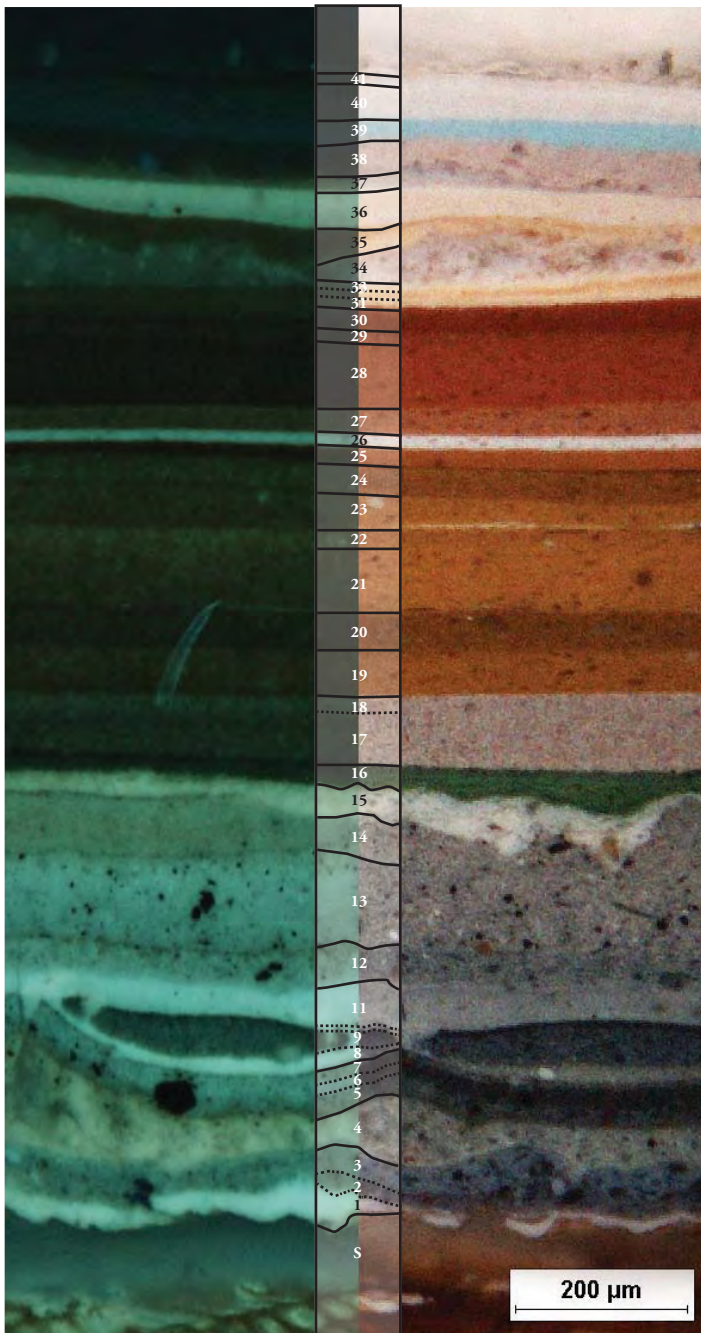
Sample Number: 4 :A: 4	Element: wall	Date Sampled: 02/13/11
Sample Location: baseboard		Date Analyzed: 03/25/11
Substrate: wood	Illumination: Fluorescence BV 1A, Reflected/Quartz Halogen	
Microscope: Nikon ALPHAPHOT2-YS2		Objective: 4x
Analysis Performed by: Betty Prime		Camera: Nikon DS-Fi1

Stratigraphy
